RES Cape Fear Umbrella Mitigation Bank

PROSPECTUS

Cape Fear River Basin
HUC 03030002

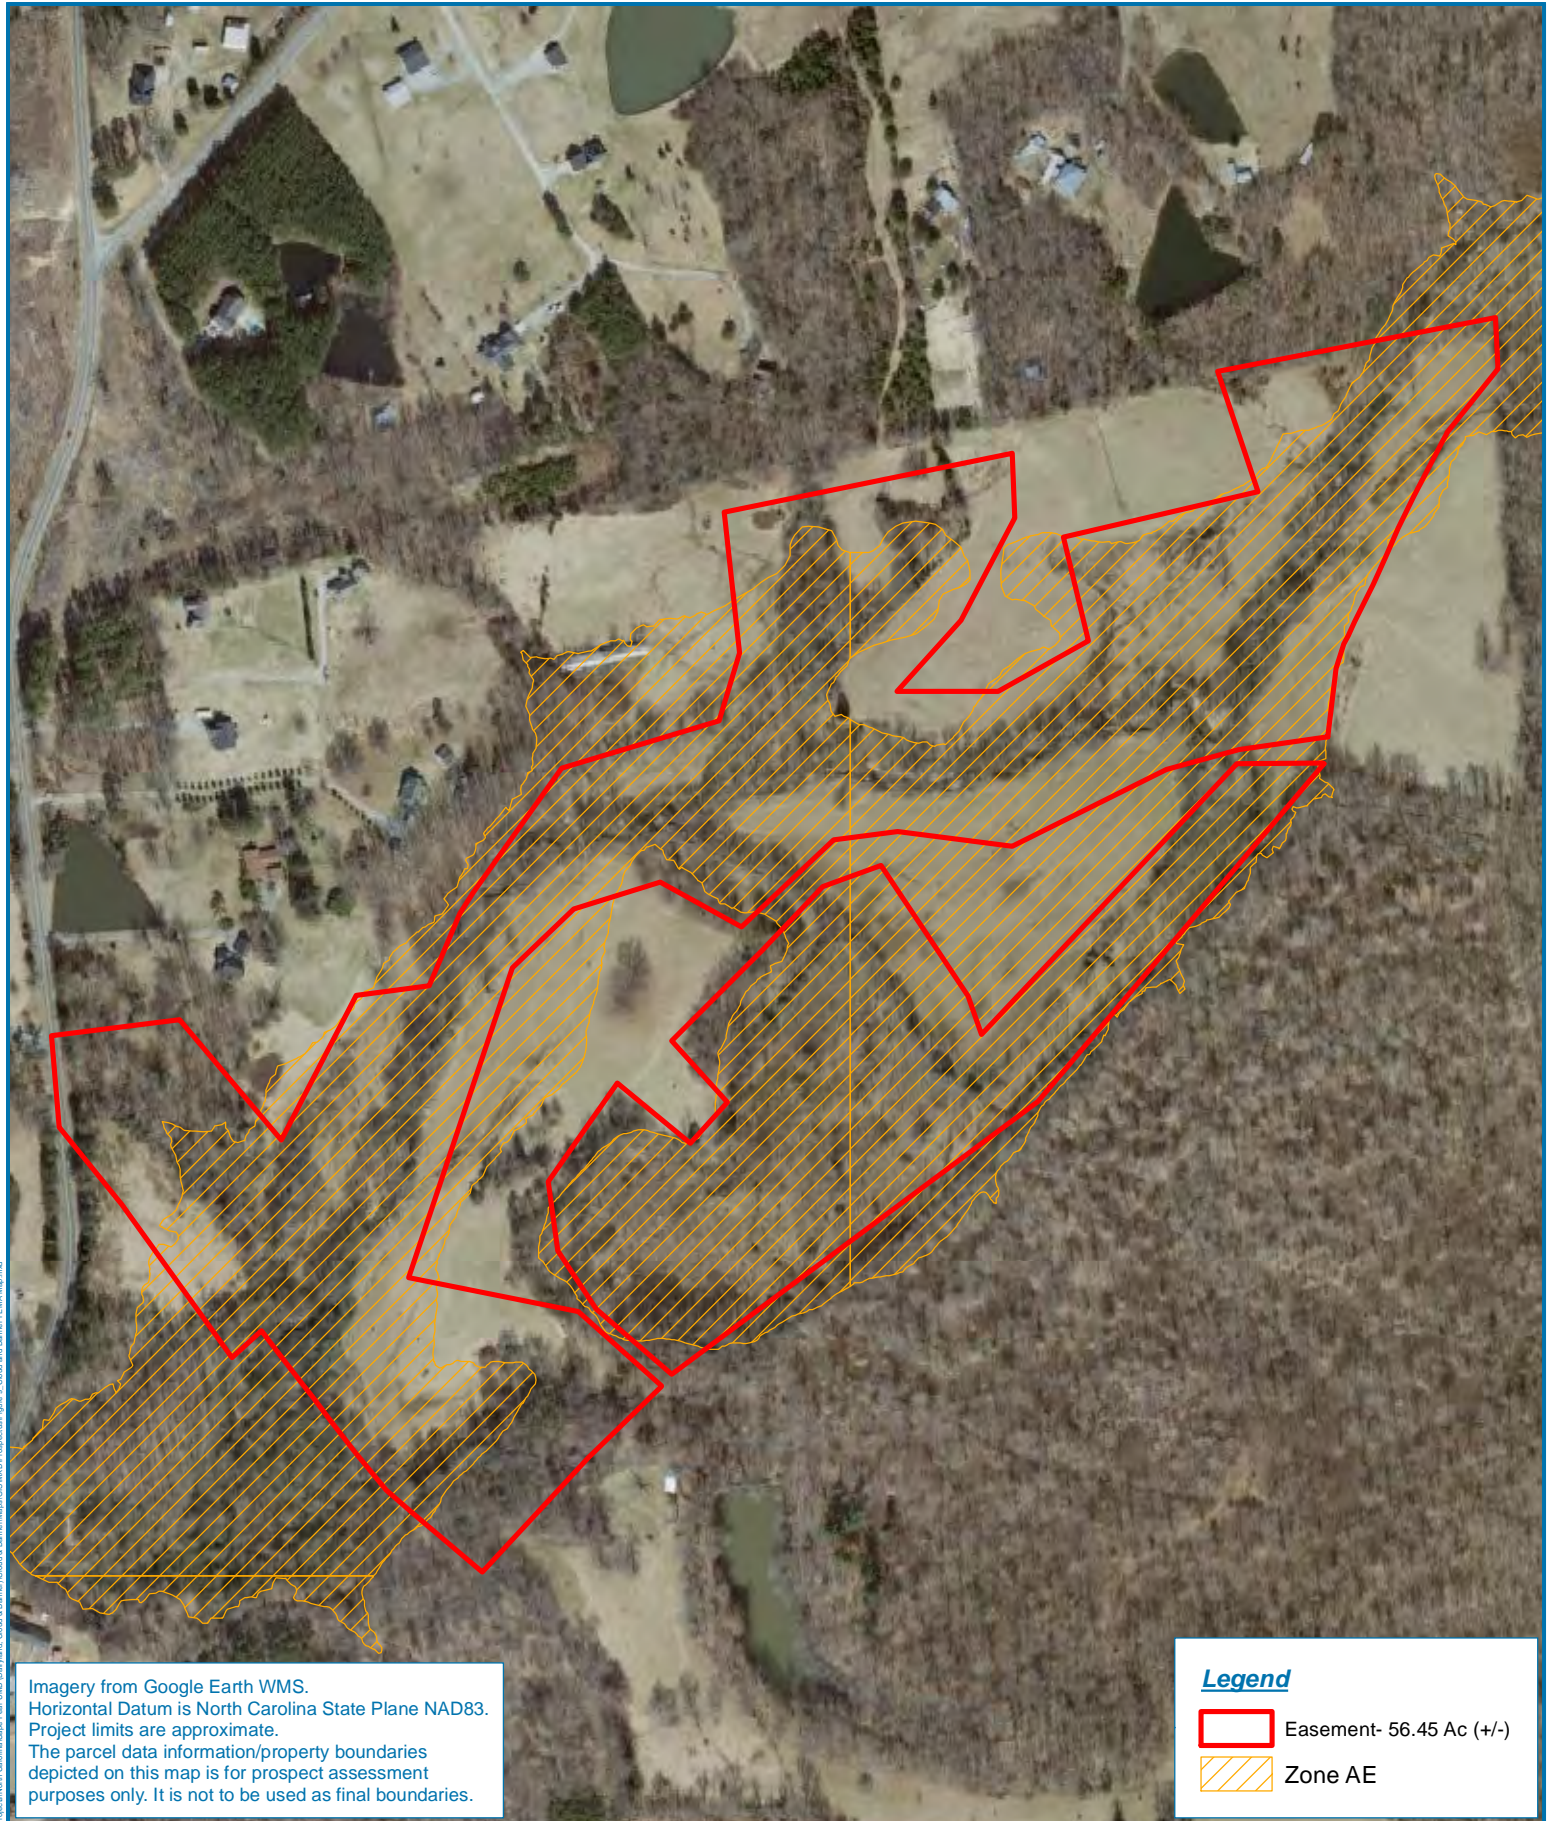
**FIGURE 9
FEMA Map**

**Cloud and Banner Mitigation Site
RES Cape Fear Umbrella Mitigation Bank**

There are no major constraints to construction of the Site. The Site is readily accessible from NC 119. Inspection of the FEMA Flood Insurance Rate Map indicates that a majority of Back Creek and associated floodplains are located within a Zone AE flood area, but no portion of the project is located within a FEMA floodway. A hydrologic analysis will be completed on the existing and proposed conditions of this reach. It is not anticipated that a No-Rise or a Conditional Letter of Map Revision (CLOMR) will need to be prepared for the site (**Figure 9**).

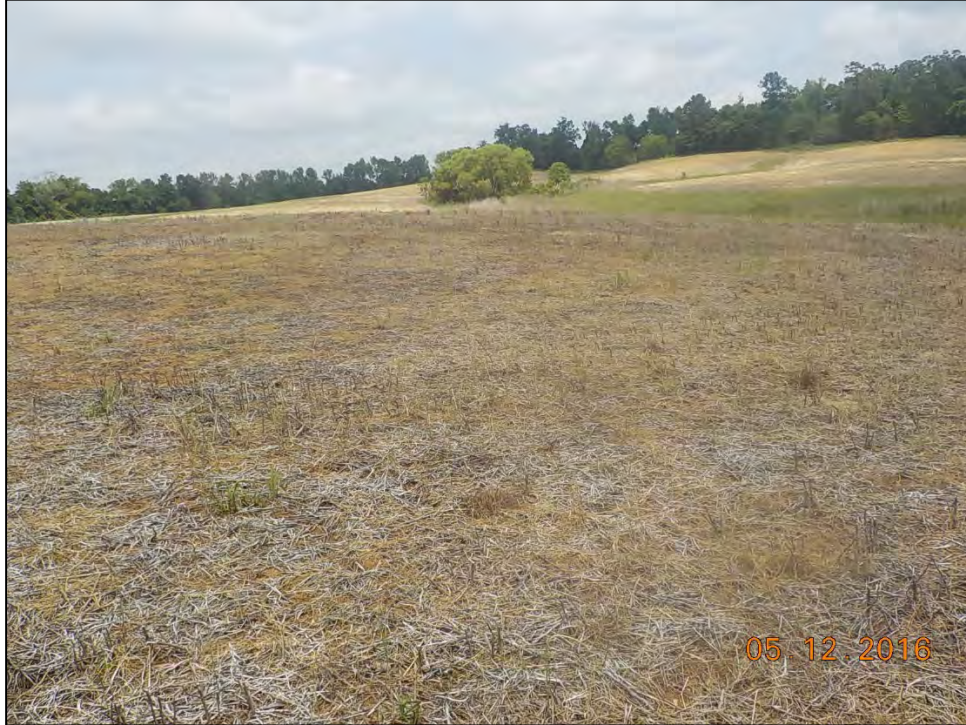
Photo 1: Upper reaches north of Dairyland Road devoid of riparian buffer

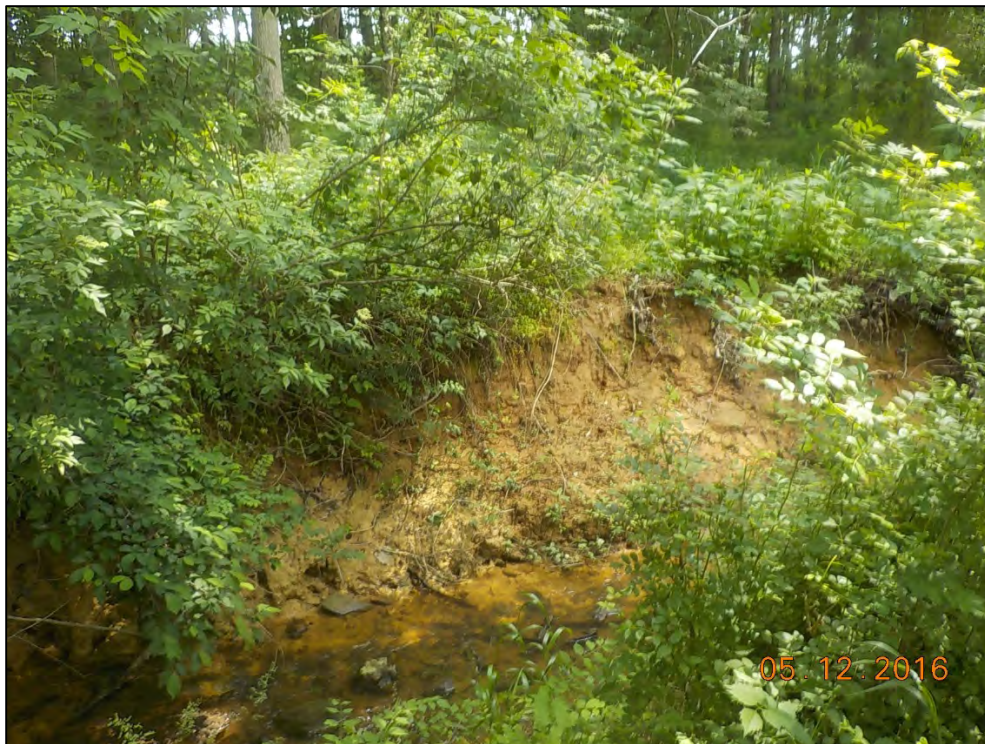
Photo 2: Active erosion along WF-1 south of Dairyland Road

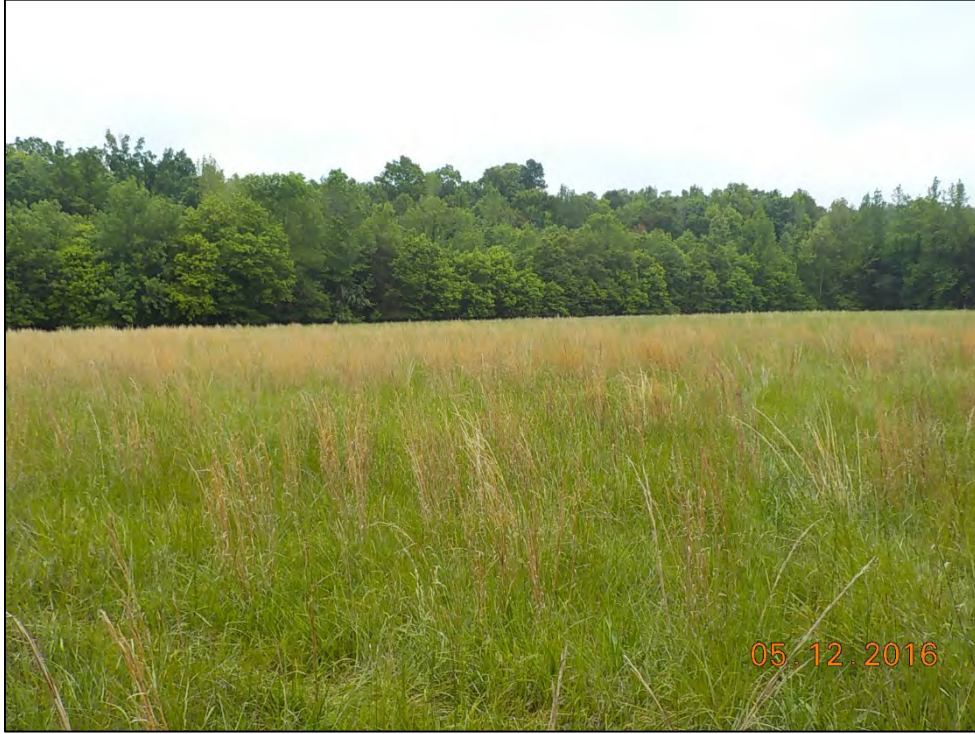
Photo 1: Existing riparian area of Reach UT4 before confluence with Back Creek

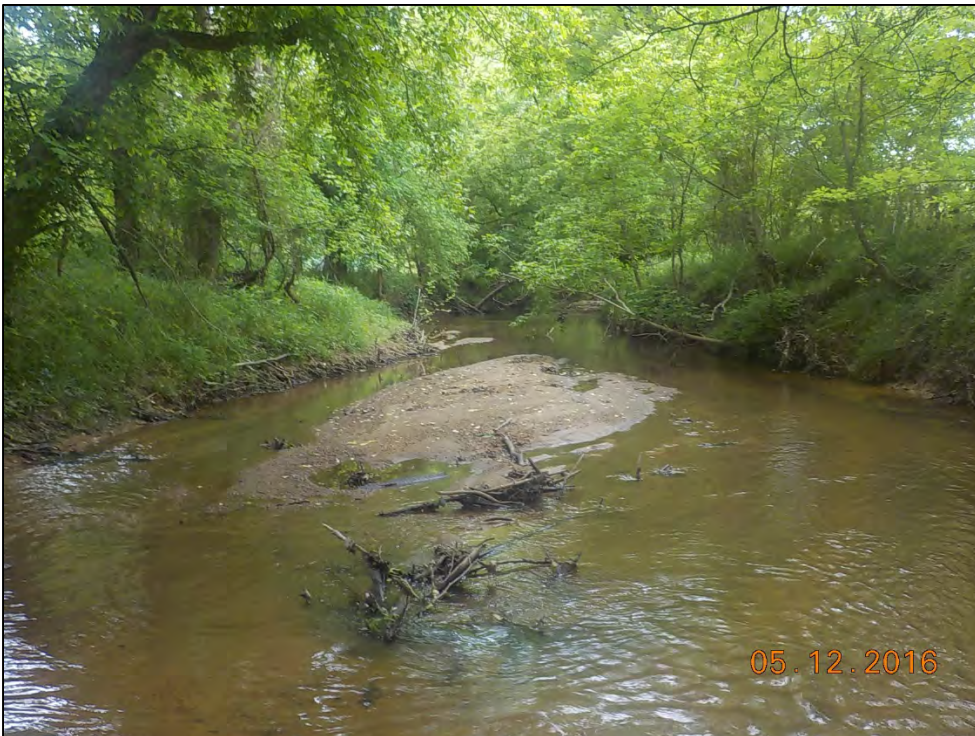
Photo 2: Back Creek at upper end of project
