MITIGATION BANK PROSPECTUS

JEAT TRACT NORTHEAST CAPE FEAR UMBRELLA MITIGATION BANK

Pender County, North Carolina

October 6, 2016

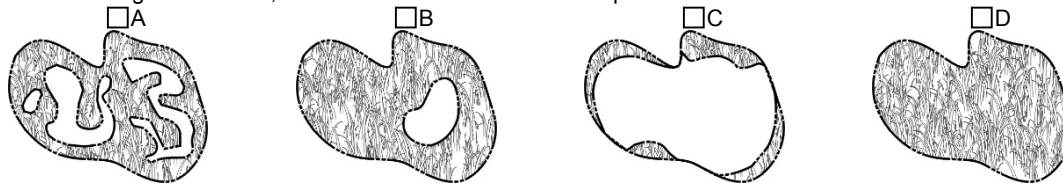
Select the figure that best describes the amount of interspersion between vegetation and open water in the growing season. Patterned areas indicate vegetated areas, while solid white areas indicate open water.

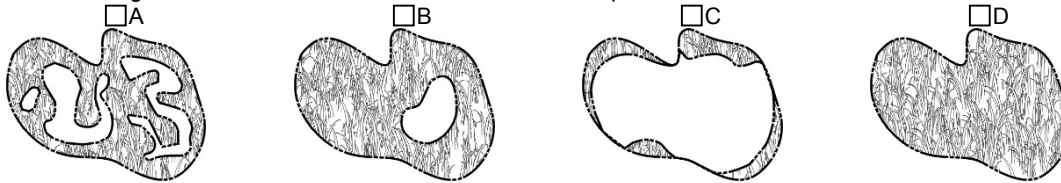
Select the figure that best describes the amount of interspersion between vegetation and open water in the growing season. Patterned areas indicate vegetated areas, while solid white areas indicate open water.

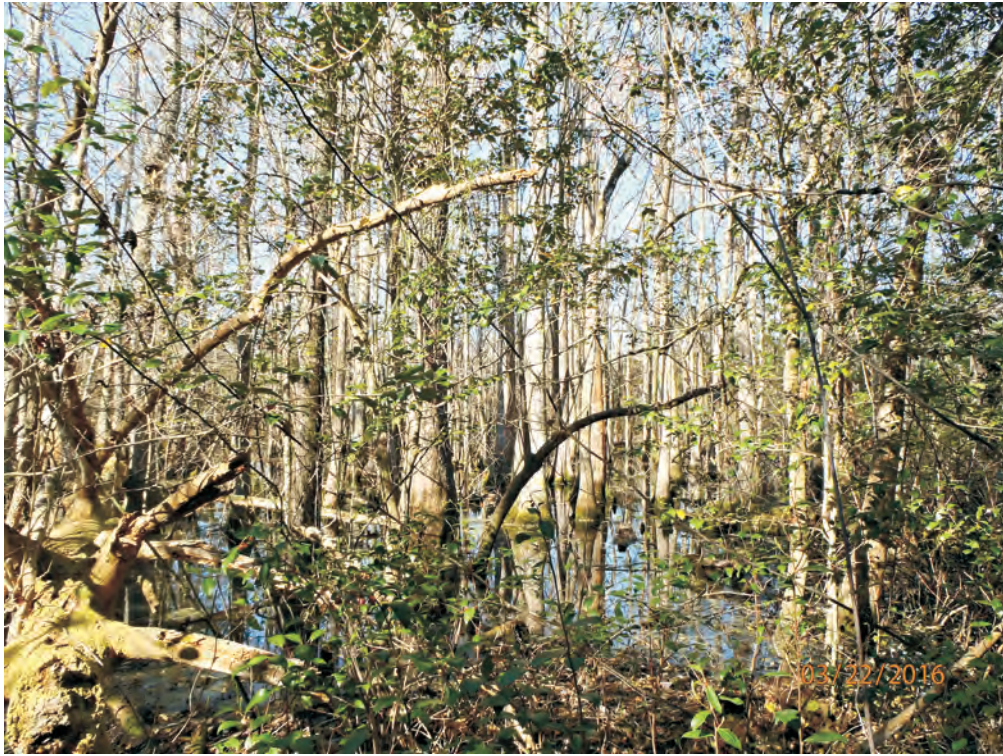
(3) View of southern wetland where NC WAM form AA1 was completed

wetland type in North Carolina (NCWFAT 2010). NC WAM generates two wetland functional ratings: the first is a reflection of wetland condition as represented by on-site indicators of function, and the second is wetland condition as modified by wetland opportunity (determined by the condition of the watershed draining to a specific wetland) (NCWFAT 2010). For this site, NC WAM has been used to consider the chemical, physical, and biological functions for each wetland polygon and assess the general performance of each function relative to the wetland type. The functional ratings of both of these wetland polygons was High. Refer to Appendix C for a compilation of the functional ratings for each wetland. The enclosed site photographs depict existing conditions of the wetlands proposed for preservation (Appendix D).

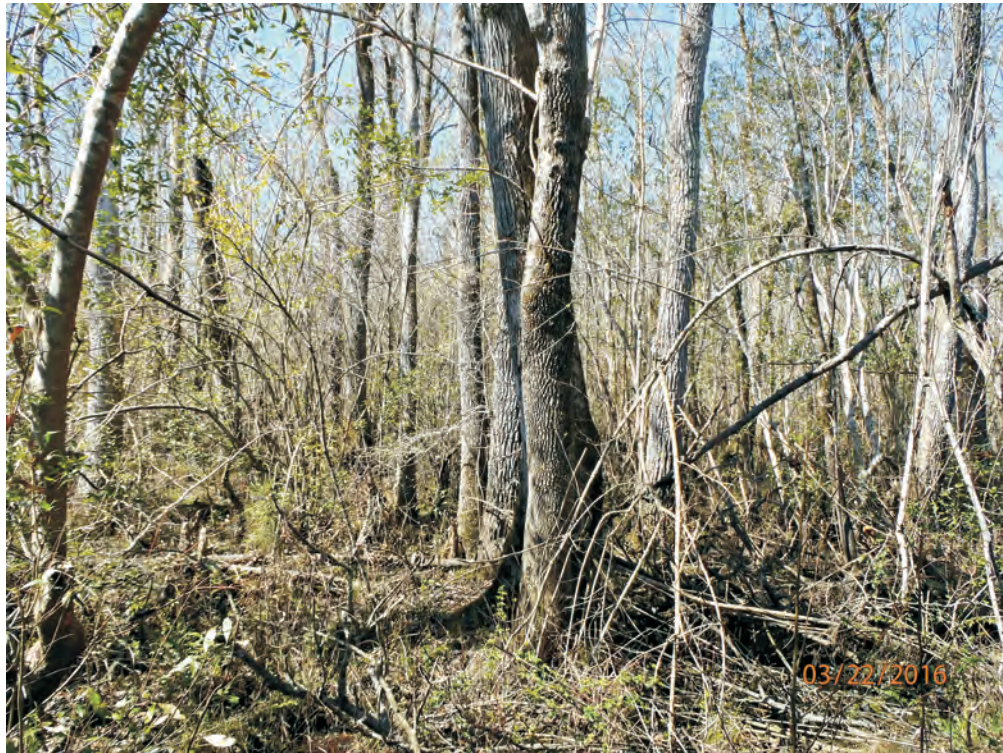
(4) View of northern wetland where NC WAM form AA2 was completed

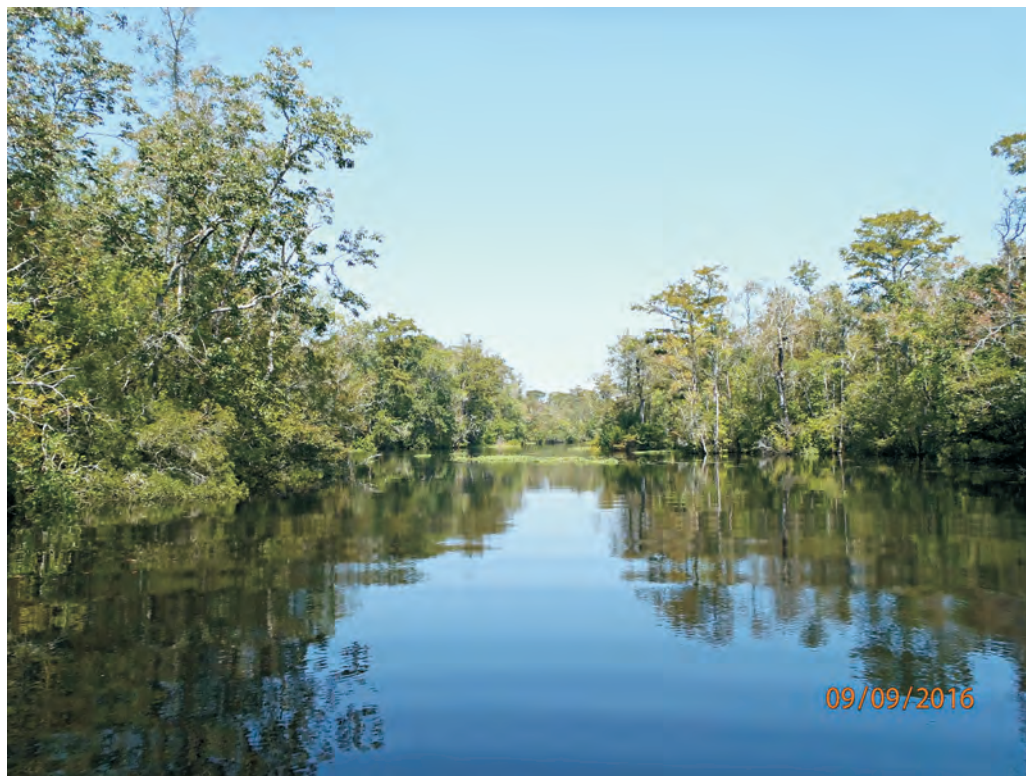
(2) View of Stream 1

The riverine floodplain abutting the streams contain several large specimens of bald cypress (*Taxodium distichum*) and swamp black gum (*Nyssa biflora*). At the time of the stream assessment (September 2016), the floodplain exhibited several feet of inundation. The floodplain canopy abutting Stream 6 is less mature than at the other streams but is still adequate for stream shading. Refer to Appendix F for site photographs of existing conditions at the streams and associated floodplain.

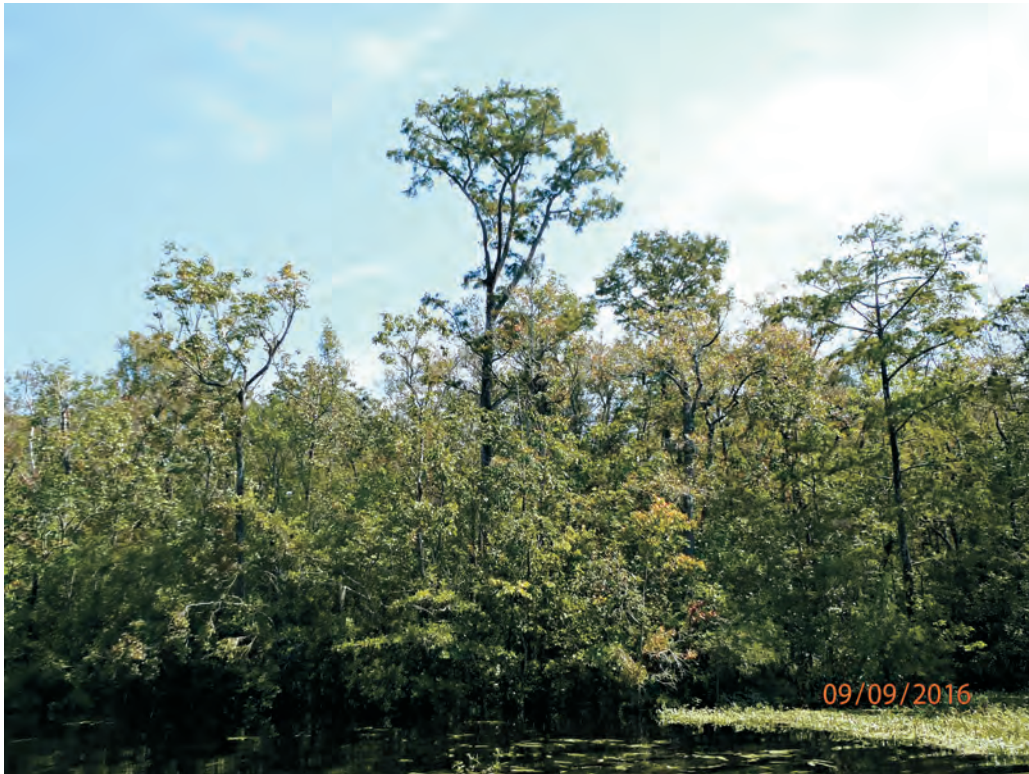
(3) View of floodplain abutting Stream 1

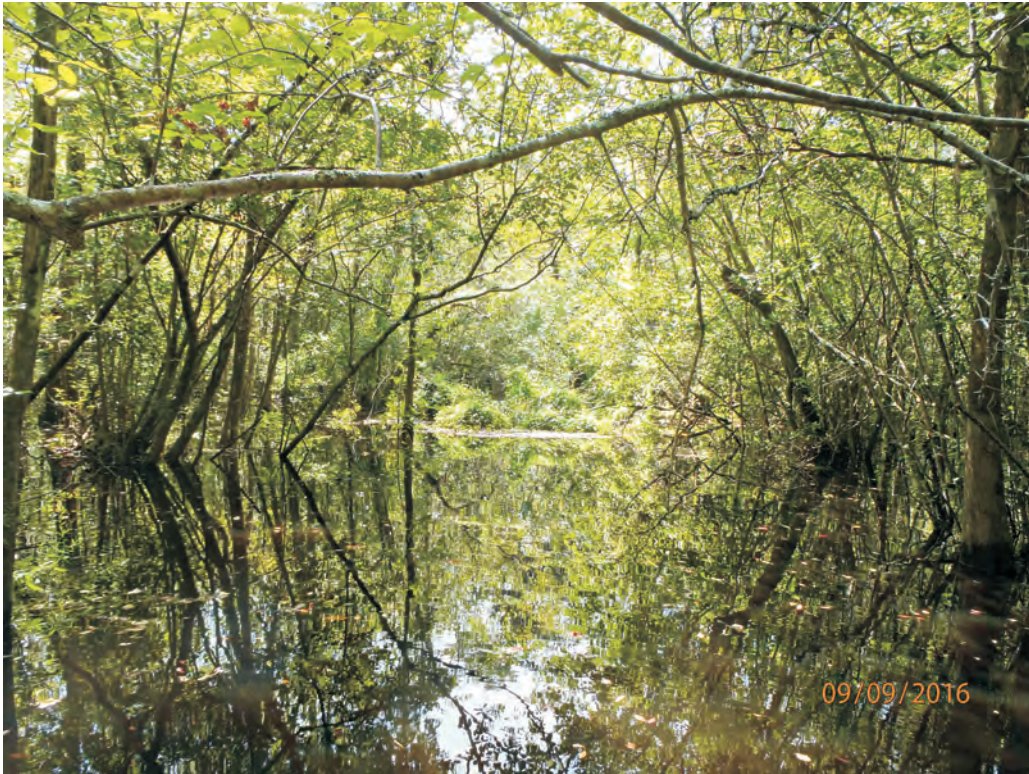
(4) View of Stream 3

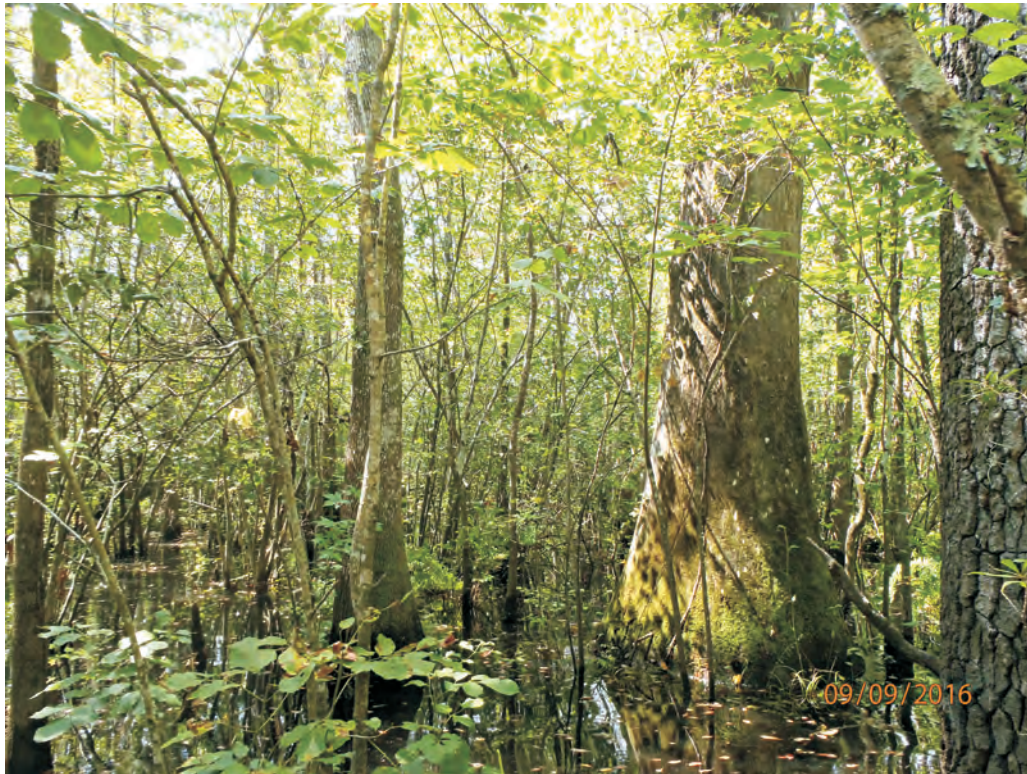
(6) View of floodplain near origin of Stream 5

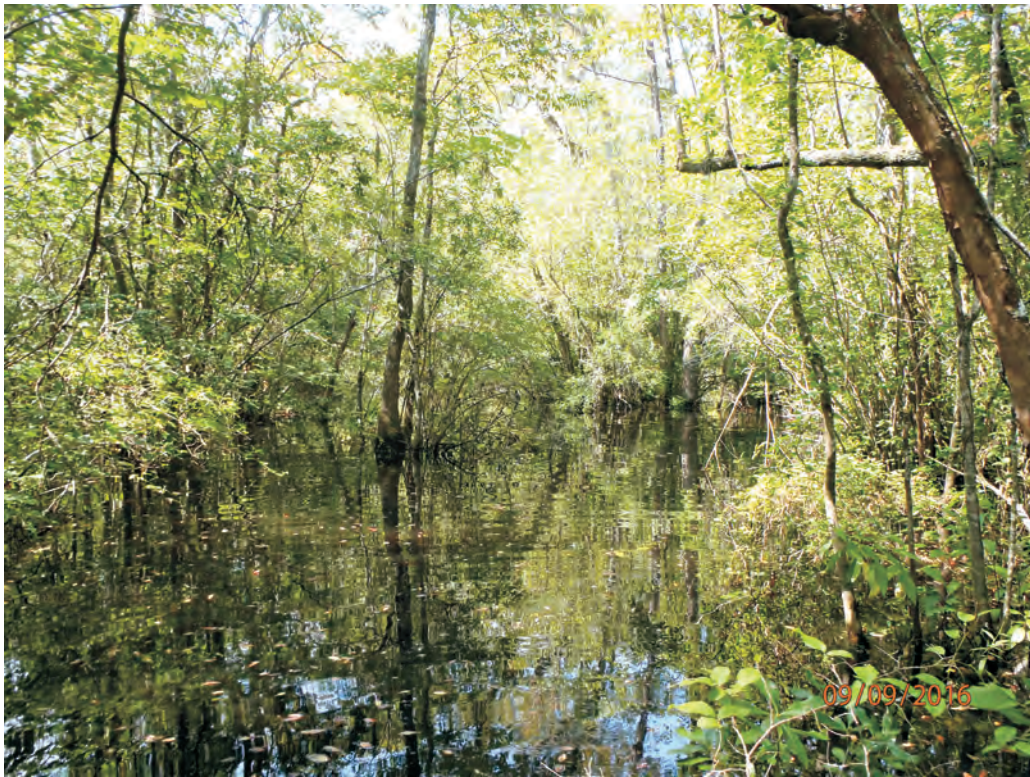
(7) View of Stream 5

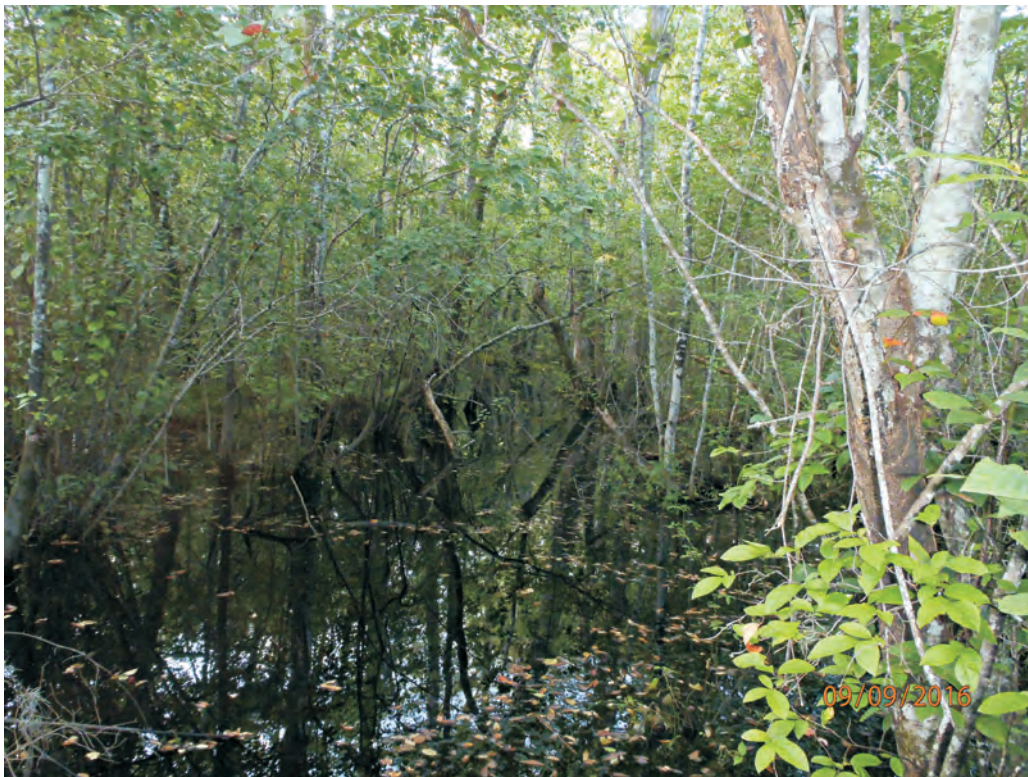
(8) View of Stream 6 near origin

The majority of the stream reaches are accessible from the river by boat during high water conditions. Streams 4 and 6 are not accessible by motorboat due to a high concentration of aquatic macrophytes at the downstream confluences of the streams with the river. The streams range in width from approximately 15 feet to 100 feet. Depth ranges from approximately 4 feet to >8 feet (limit of sampling equipment used during the stream assessment). A relatively large, stable beaver dam was observed at Stream 4 approximately 200 feet below the stream origin.
