Village of  
Bald Head Island, N.C..

Olsen Associates, Inc.  
2618 Herschel Street  
Jacksonville, FL 32204  
(904) 387-6114  
(Fax) 384-7368  
olsen-associates.com  
C-1468

August 2017

# Bald Head Island, N.C. Jay Bird Shoals Borrow Site Re-Evaluation

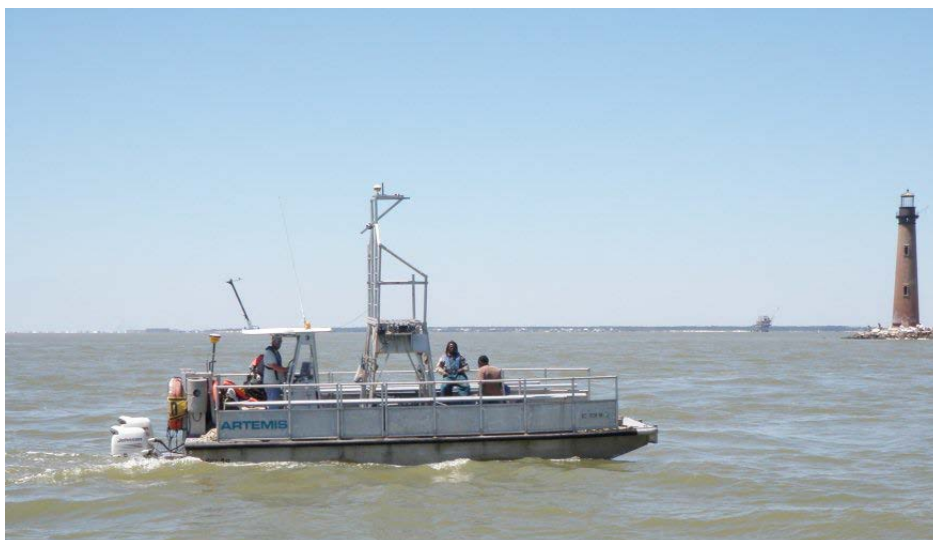
**Figure 2: Research Vessel Artemis offshore of Mobile Bay, Alabama.**

Athena utilized the 35-foot research vessel, *Artemis* (Figure 2), to act as the sampling platform for this project. *Artemis* was equipped with all required US Coast Guard (USCG) safety gear and was operated by a USCG-certified, 100 Ton Master Captain. A Trimble Differential Global Positioning System (sub-meter accuracy) interfaced with HYPACK was utilized for primary navigation. Horizontal coordinates were recorded in North American Datum of 1983 State Plane Coordinate System, North Carolina (Zone 3200), U.S. Survey Feet. Real-time tide elevation data was obtained using a Champion TKO Global Navigation Satellite System receiver interfaced with the North Carolina Continuously Operating Reference Station Network, which served as the base station.

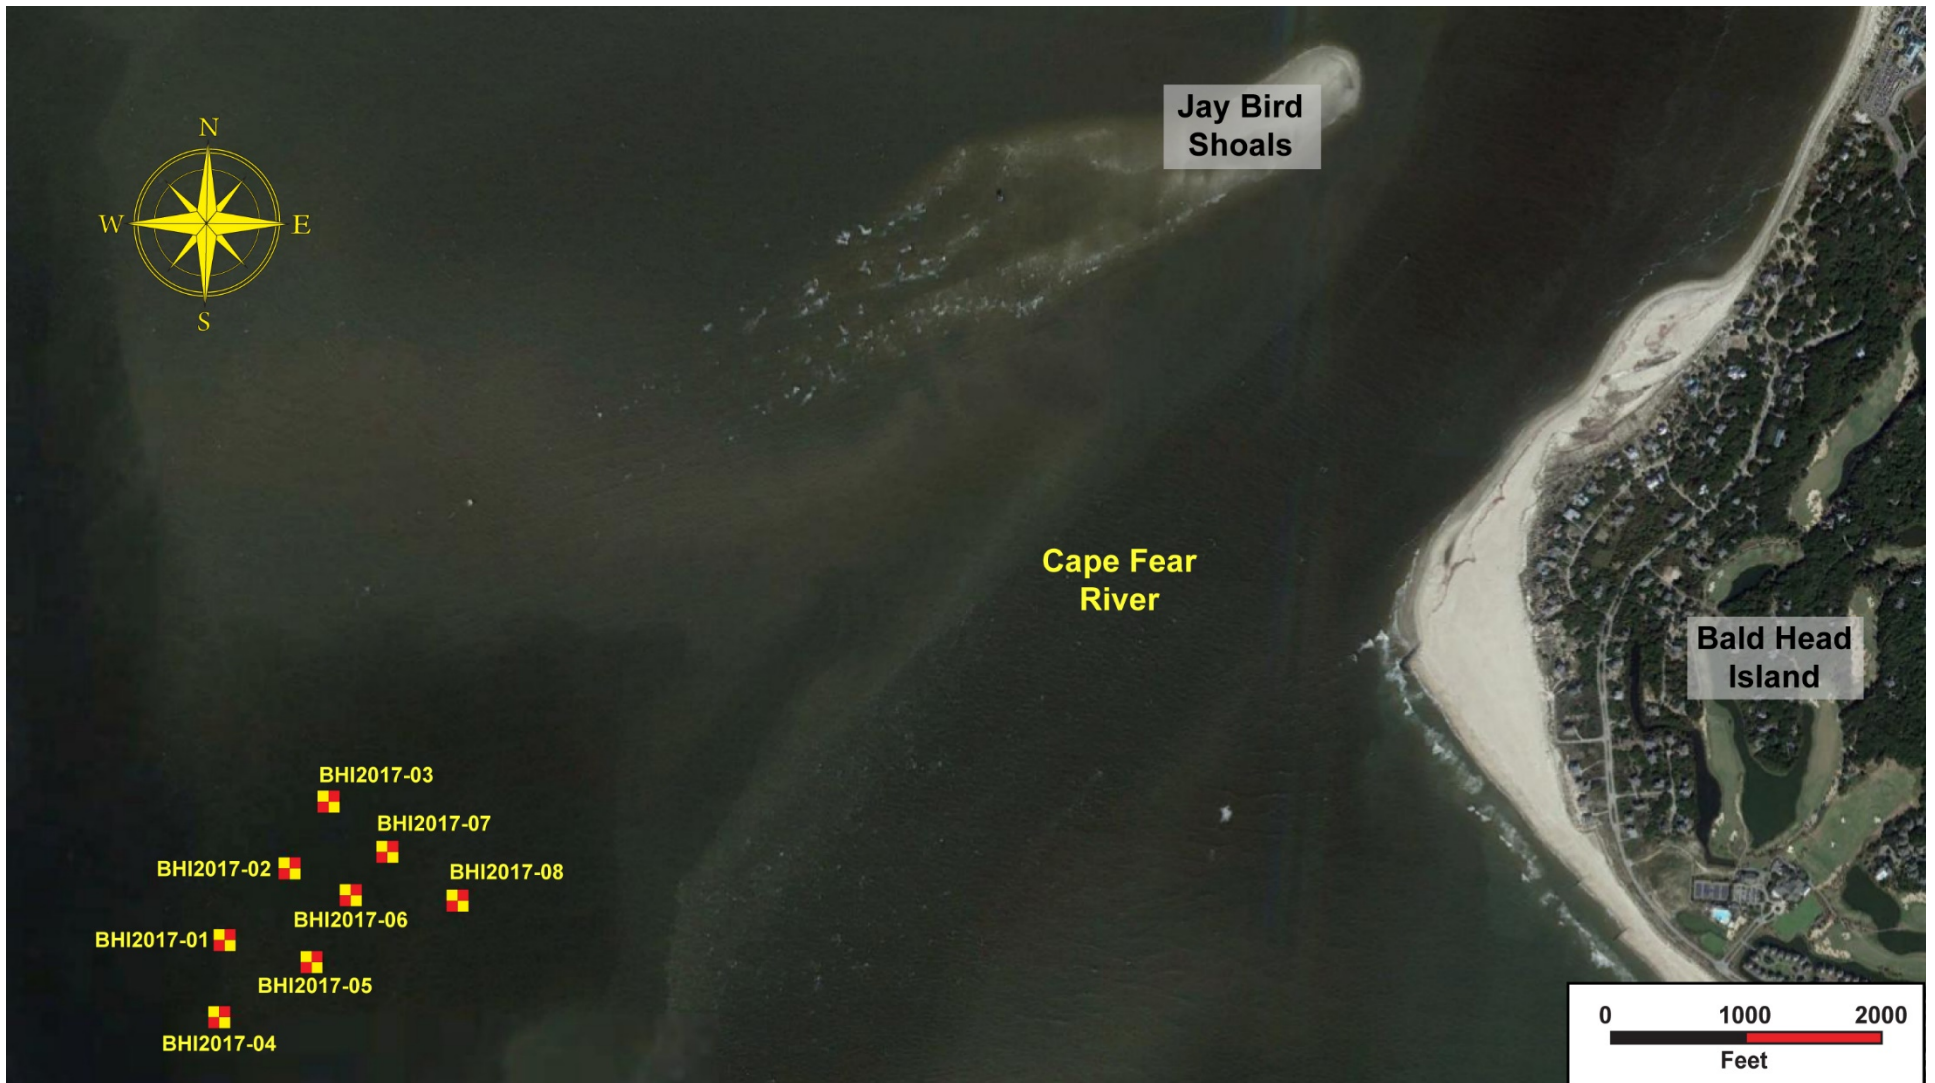
Figure 3: Vibracore Location Map, Jay Bird Shoals, Bald Head Island, North Carolina. (Image Source: Google Earth)

A custom-designed and fabricated vibracore system was utilized to collect the geotechnical cores. The system consists of a generator with a mechanical vibrator attached via cable. The vibrator is attached directly to a 3-inch diameter, galvanized sample barrel. The sample barrel was lowered until the bottom of the barrel was directly above the sediment surface. The vibracore machine was turned on and the sample barrel was allowed to penetrate to a depth of 20 feet below sediment surface, or to refusal. Vibracore penetration was recorded from the deck using marked drill stems. Once the sample barrel reached the desired depth, the machine was turned off and the sample barrel was retrieved using an electric winch. The recovered core length was measured following core retrieval, and percent recovery was verified. The cores were then capped, labeled, and cut into 5-foot sections. A vibracore summary table containing final location coordinates, elevation data, and penetration and recovery lengths has been included as Table 1. Sample locations are depicted on Figure 3.

Water depths at the sample locations within the study area ranged from 14.3 to 16.3 feet and sediment surface elevations ranged from -10.4 to -14.9 feet NGVD 29. In general, the maximum penetration depth achieved while vibracoring decreased with increasing sediment surface elevation. The increase in density at the shallower sample locations is likely caused by a greater exposure to higher energy wave action at those locations. As a result, vibracore penetration depths ranged from 12.5 feet to 21 feet below sediment surface in the study area; core termination depths ranged from -22.9 to -34.9 feet NGVD 29. It should be noted that the relatively shallow nature of the study area, in conjunction with the study area's exposure to open ocean processes (e.g., wave refraction), resulted in amplified wave heights and variable wave directions at the sample locations. The wave action within the study area caused the vessel to pitch and surge in a non-uniform manner, which made safety an overriding concern during vibracore operations. All reasonable efforts were made to collect vibracores from the desired locations while minimizing risk to crew and equipment.

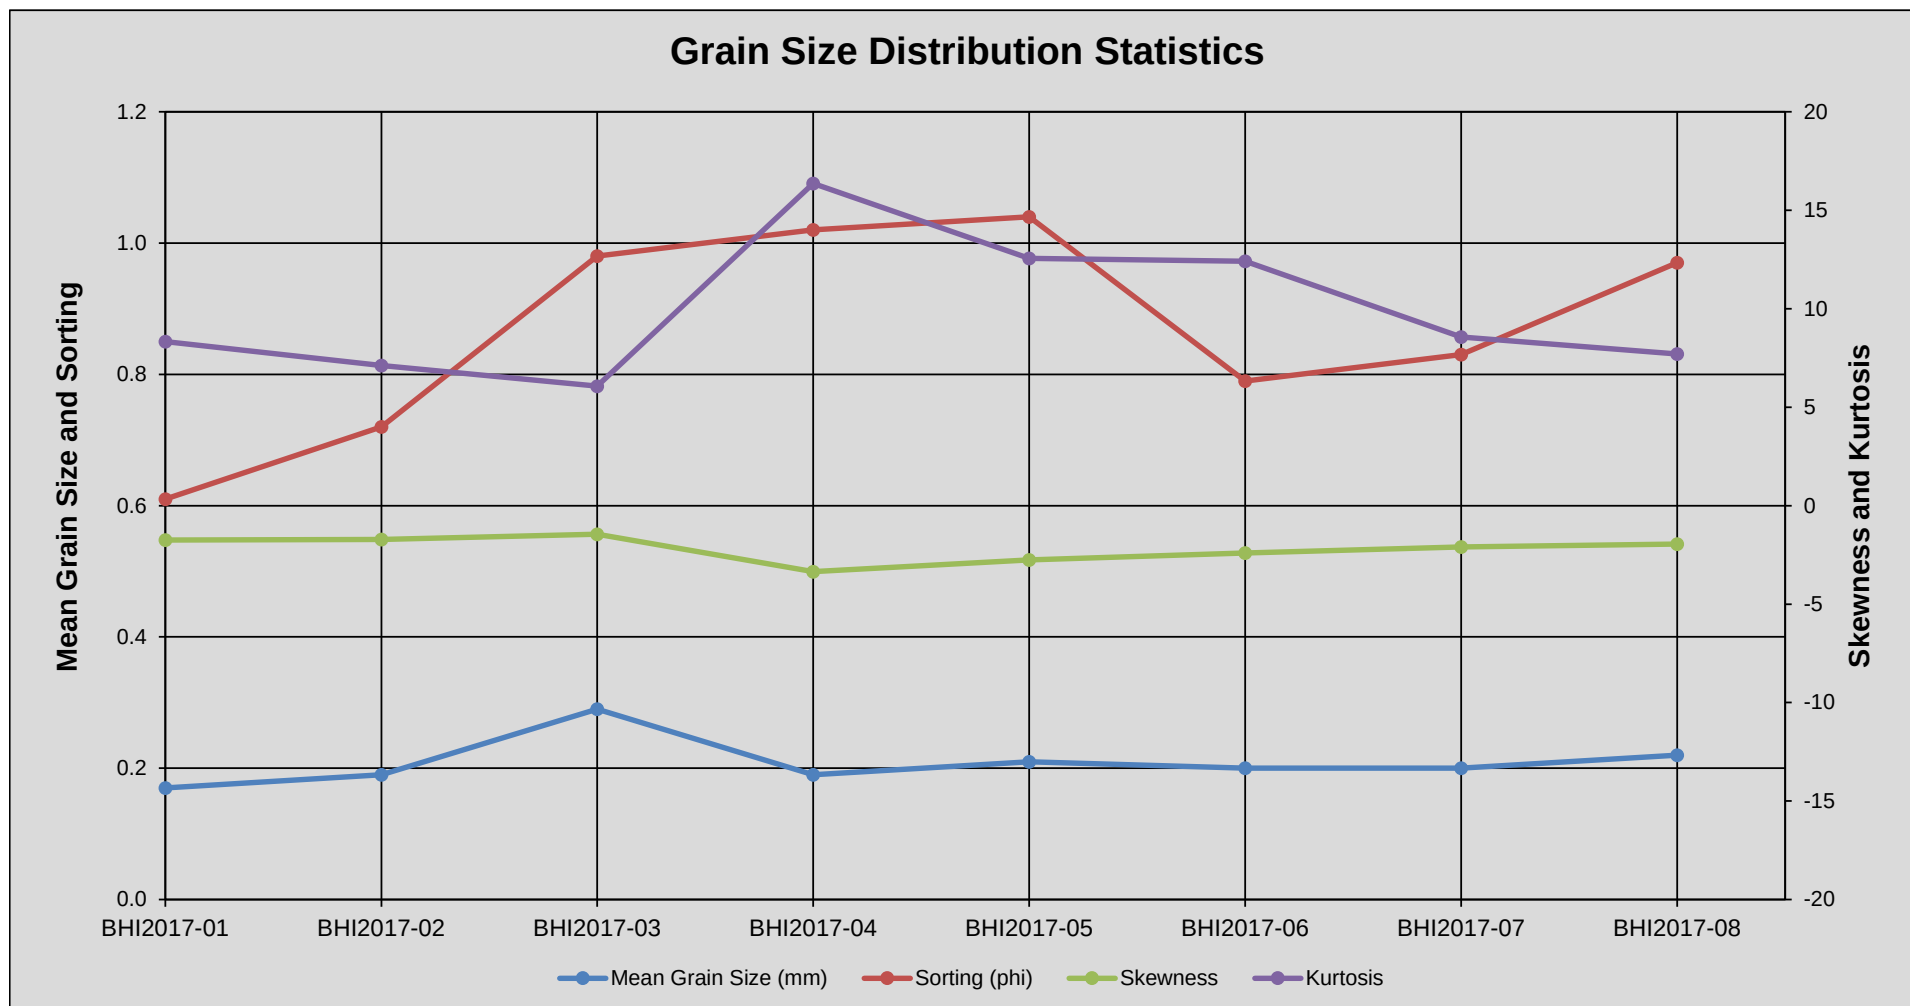
Appendix C  
Grain Size Data Summary Graphs  
Olsen Associates, Inc.  
Jay Bird Shoals, Bald Head Island, North Carolina  
July 2017
