**BEACH RESTORATION TO PROTECT NC HIGHWAY 12  
AT BUXTON, DARE COUNTY, NORTH CAROLINA**

**BIOLOGICAL ASSESSMENT**

**CAPE HATTERAS NATIONAL SEASHORE**

**SEPTEMBER 2015**

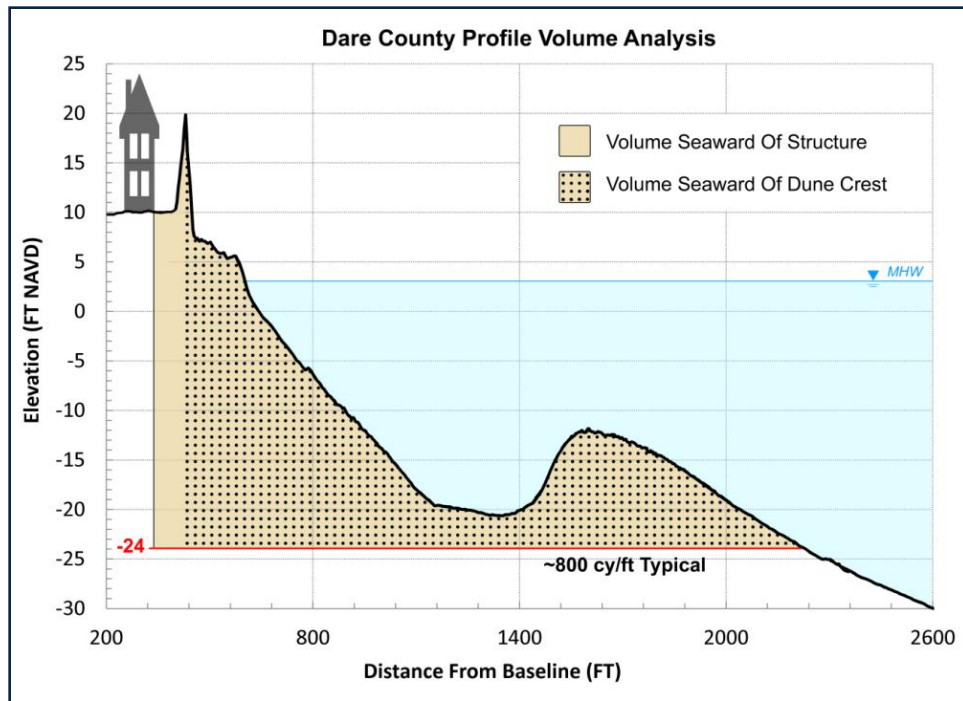
**FIGURE 3.3.** Illustration of the two lenses used in the profile volume analysis for Buxton. The first volume quantifies sand contained between the approximate foredune crest and -24-ft NAVD. The second calculates the volume between the seaward most structure (buildings or road) in the vicinity of the profile and -24-ft NAVD. Based on typical dimensions in the project area, the hatched cross-section shown here has a 2-D area of ~21,600 square feet. This is equivalent to a "unit volume" of 800 cu yd/ft (i.e. – 800 cu yd are contained in a 1-ft length of beach – see Fig 3.2).

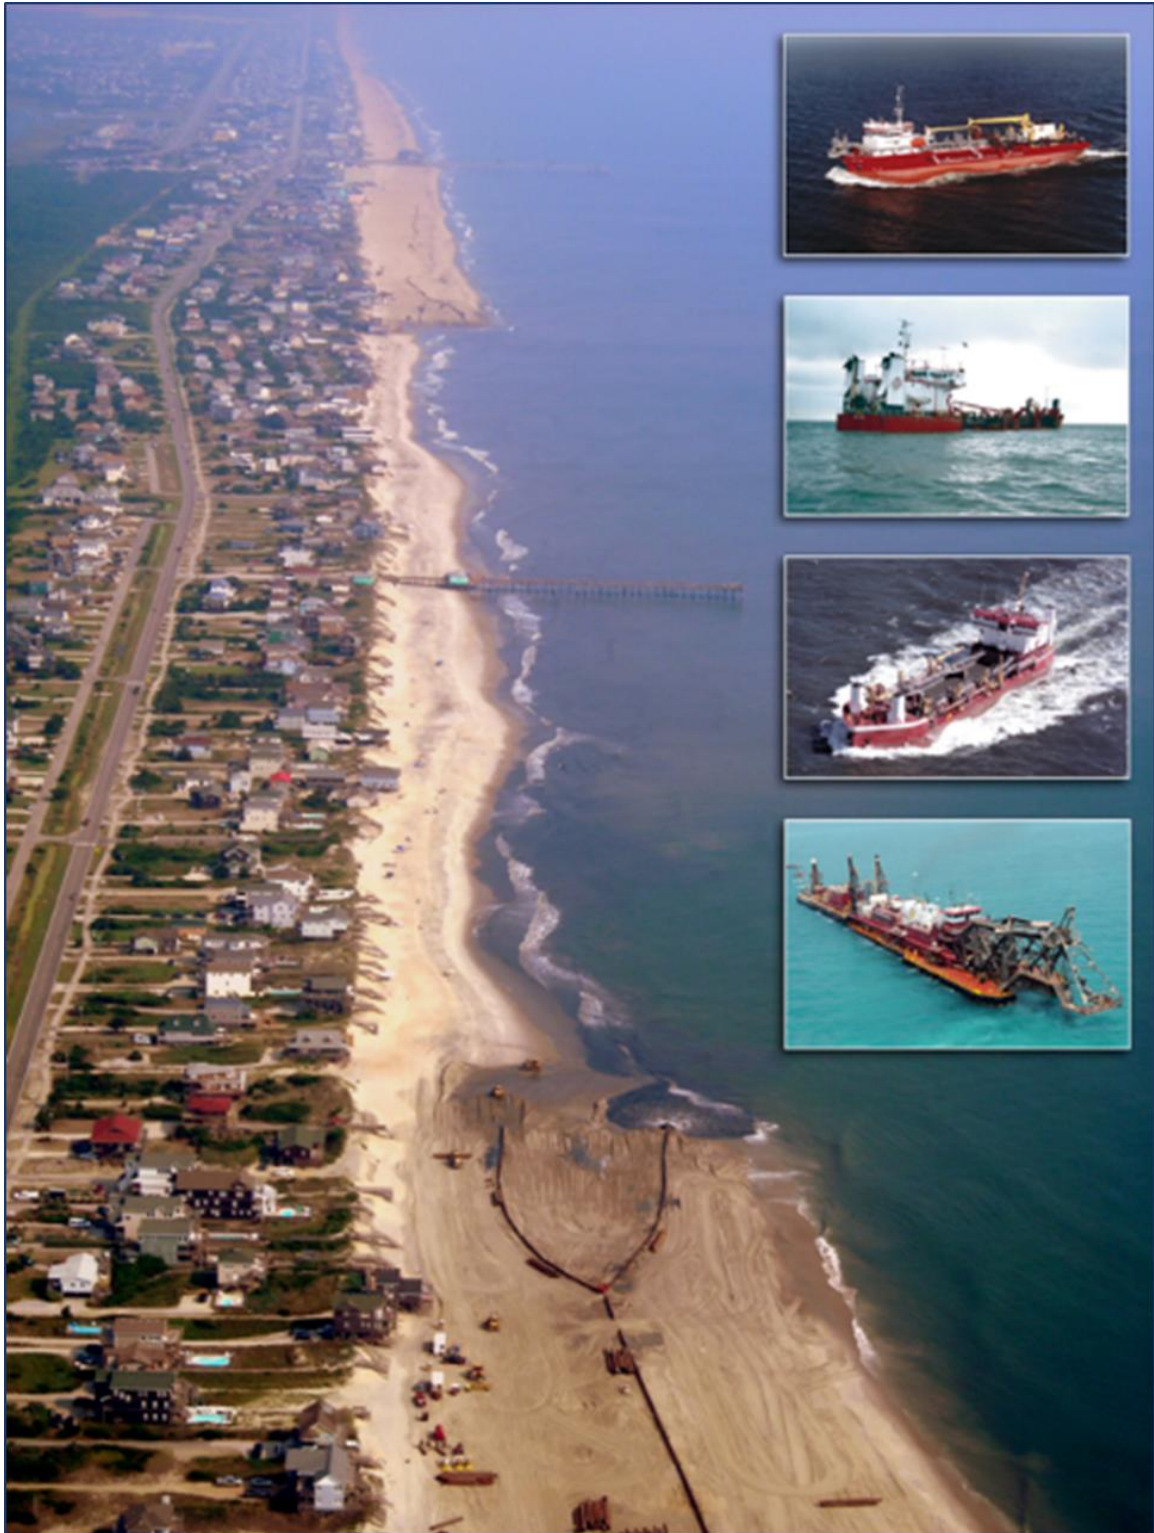
**FIGURE 3.11.** Three hopper dredges and one suction cutterhead dredge (inset photos) were used to construct the Nags Head (NC) beach nourishment project (24 May to 27 October 2011). Image shows nourishment construction in progress working south to north toward Outer Banks Pier in south Nags Head. [Photos by CSE and Great Lakes Dredge & Dock Co.]
