## CHAPTER 3 – AFFECTED ENVIRONMENT – EXISTING CONDITIONS

### COASTAL RESOURCES (INCLUDING LITTORAL PROCESSES)

### **Condition Survey, Sand Deficit, and Annual Erosion Rates**

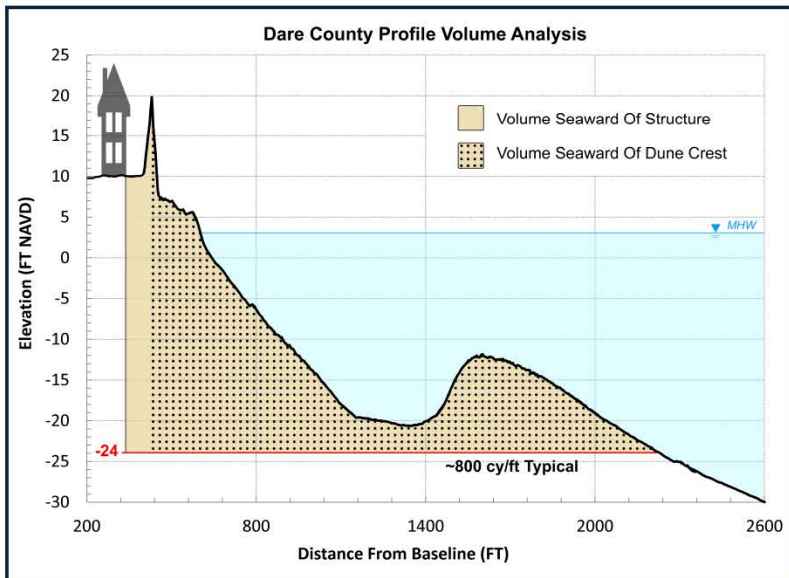
Figure 3.2.

Diagram showing a cutaway cross-section of the dune, beach, and inshore zone illustrating two area calculation lenses. The area under the beach profile to a reference depth of -24 ft NAVD (i.e. ~24 feet below mean sea level) is converted to an equivalent volume of sand contained in a 1-foot length of beach. The first volume quantifies sand contained between the approximate foredune crest and -24-feet NAVD. The second calculates the volume between the seaward most structure in the vicinity of the profile and -24-feet NAVD.

Based on typical dimensions in the project area, the hatched cross-section (referencing the dune crest) shown here has a 2-D area of ~21,600 square feet. This is equivalent to a unit volume of 800 cubic yards/foot (i.e. 800 cubic yards are contained in a 1-foot section of beach).

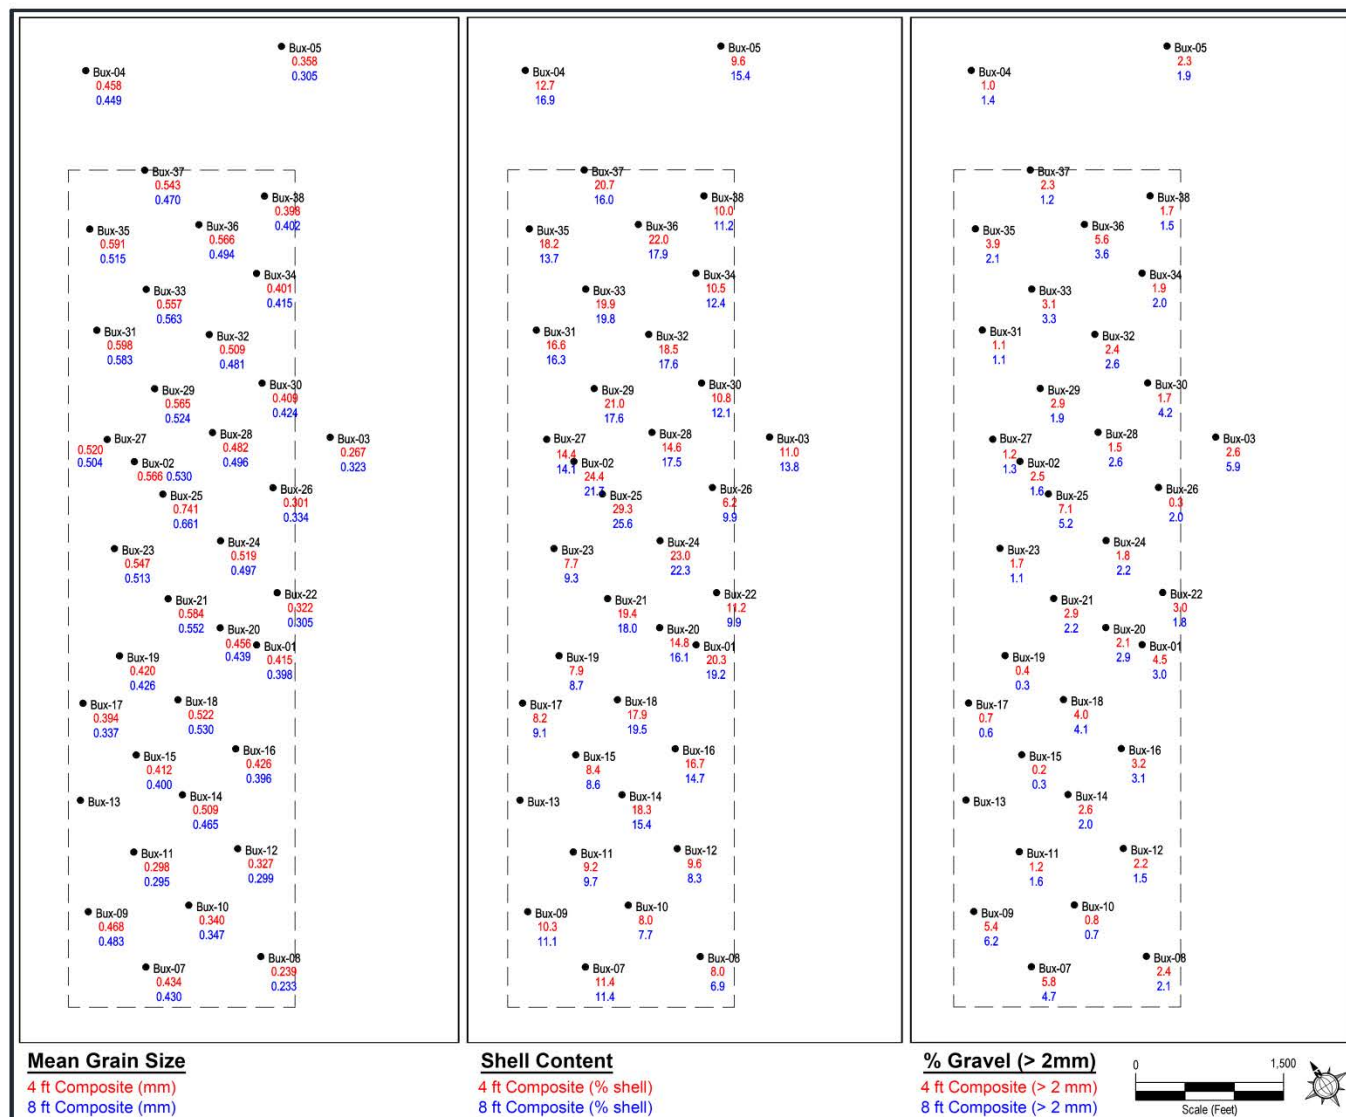
**Figure 3.10.** Maps of the core locations within the proposed borrow area (three panels) showing mean grain size, percent shell, and percent gravel for core composite samples to 4 feet and 8 feet in the Buxton offshore sand search area based on borings obtained in October 2014. Bux-13 was attempted but not recovered. Composite results to 6 feet (not shown) fall between the results for 4 feet and 8 feet.

Figure 3.10 summarizes key statistics for each core in the offshore borrows area. Weighted composites to 4 feet, 6 feet, and 8 feet of core section were developed from random-length, individual samples. These data provide an indication of the degree of similarity between the upper and lower layers of each core. One of the environmental concerns of using offshore borrow areas is the possibility that underlying sediments after excavation would be dissimilar and would not provide the same substrate for recolonization by benthic organisms (USACE 2010, NPS 2012). The Buxton borings exhibit highly similar mean sizes, shell content, and gravel percentages in each vertical composite. This is also confirmed via color-coded isopach maps of the sets of composites (see Appendix C, Figs 4.5–4.7).

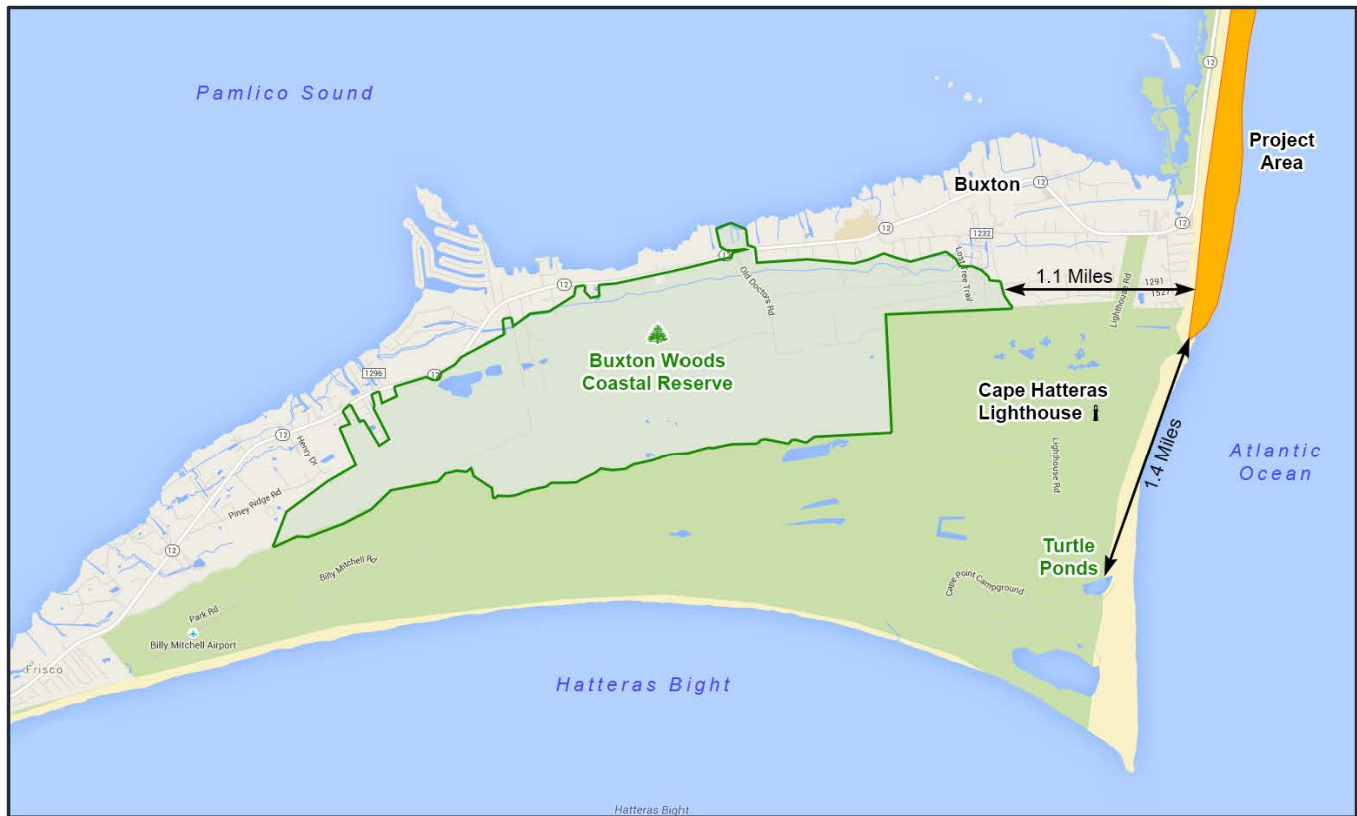
**Figure 3.11.** Map of Buxton–Cape Hatteras area showing the approximate boundaries of the Buxton Woods Coastal Reserve and Turtle Ponds, the two Natural Heritage sites located about 1 mile from the Proposed Action Area.

The Turtle Pond and Cape Hatteras Lighthouse natural area is a Registered Natural Heritage Area (RHA) under an agreement between the National Park Service and NC Department of Environment & Natural Resources. Within the Turtle Pond RHA an Interdune Pond natural community has been documented. The Buxton Woods Natural area is located just west and southwest of the Turtle Pond RHA and a portion of the Woods is also an RHA. The following natural communities have also been documented within the Buxton Woods Natural Area: Interdune Marsh, Interdune Pond, Maritime Evergreen Forest (Mid-Atlantic Subtype), Maritime Shrub Swamp (Dogwood Subtype), and Maritime Swamp Forest (Typic Subtype). These Natural Heritage Areas are depicted on Figure 3.11.

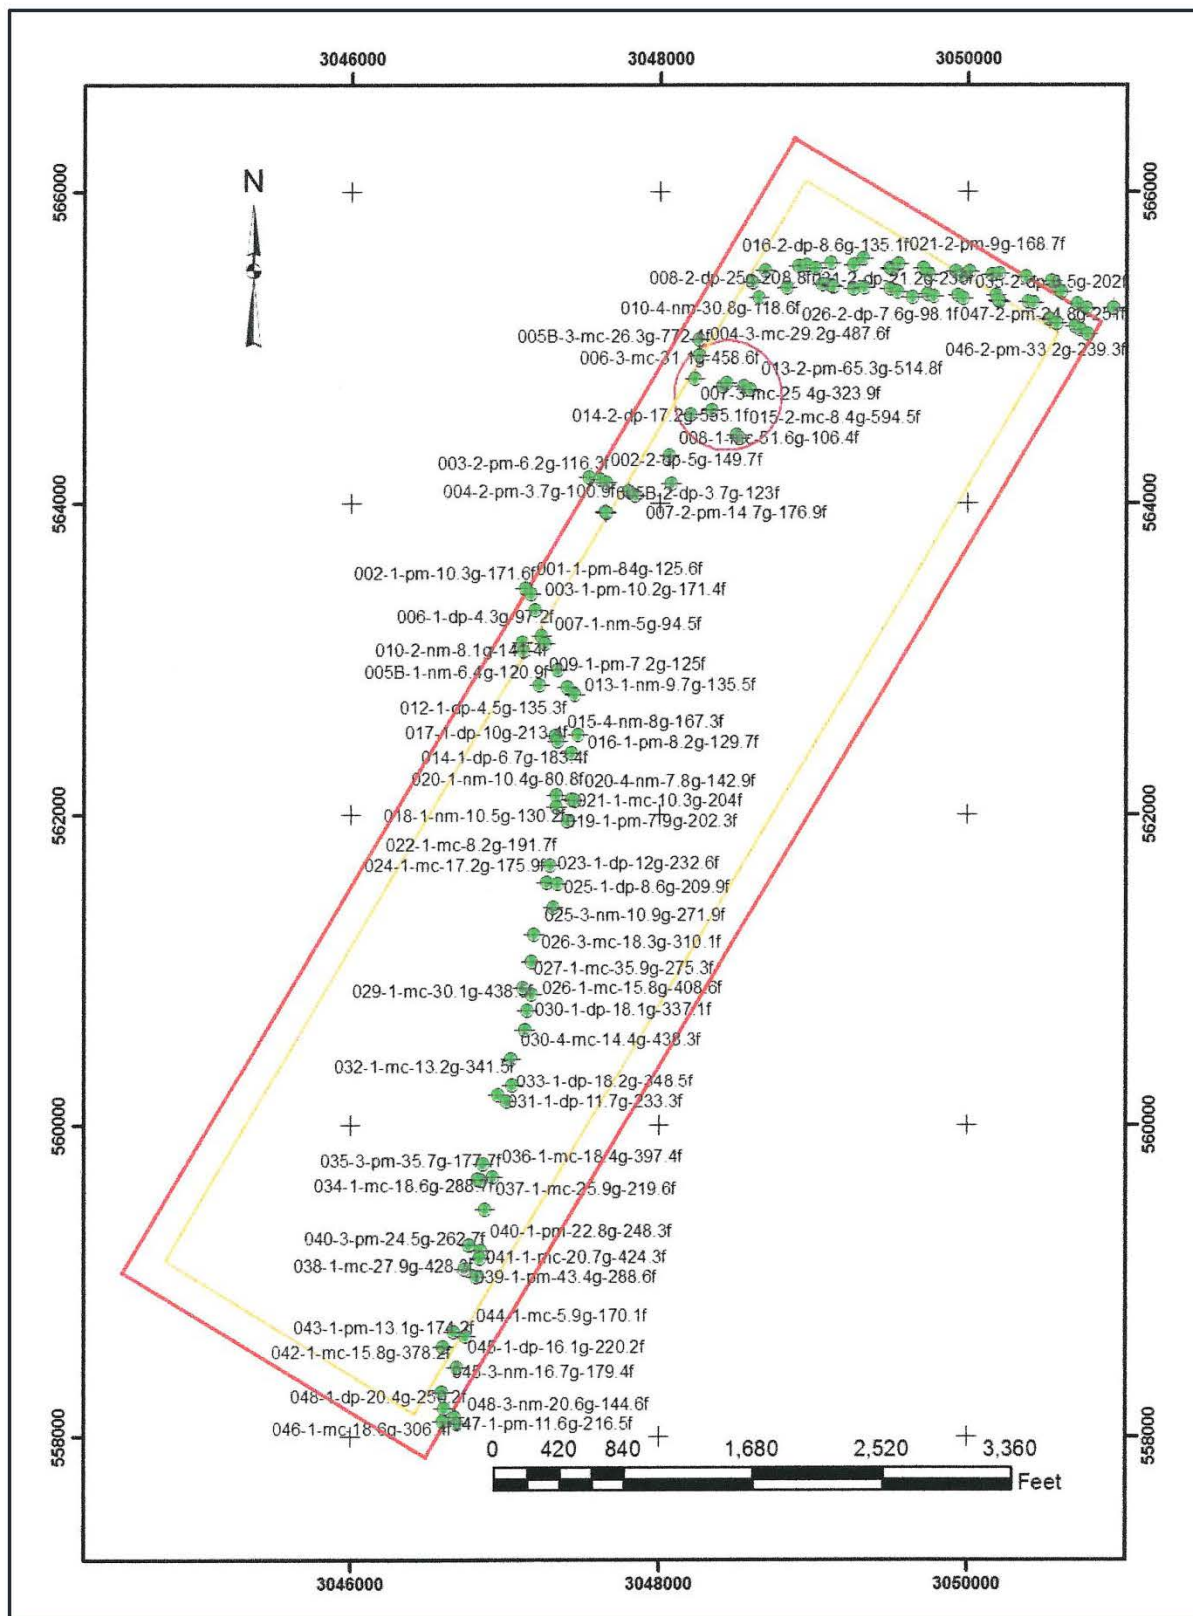
**Figure 3.13.** Map of the offshore sand search area showing magnetic anomalies (green dots) identified by Tidewater Atlantic Research (2015) in the Proposed Action Area. The majority of anomalies have an acoustic signature that is representative of cable, wire, or small-diameter pipe, except for the 10 anomalies circled near the northern end of the grid. See Appendix F – *Cultural Resources* for details.
