BOGUE BANKS MASTER BEACH NOURISHMENT PLAN

SUMMARY REPORT | MARCH 4, 2016

BOGUE BANKS MASTER BEACH NOURISHMENT PLAN CARTERET COUNTY, NC

March 4, 2016

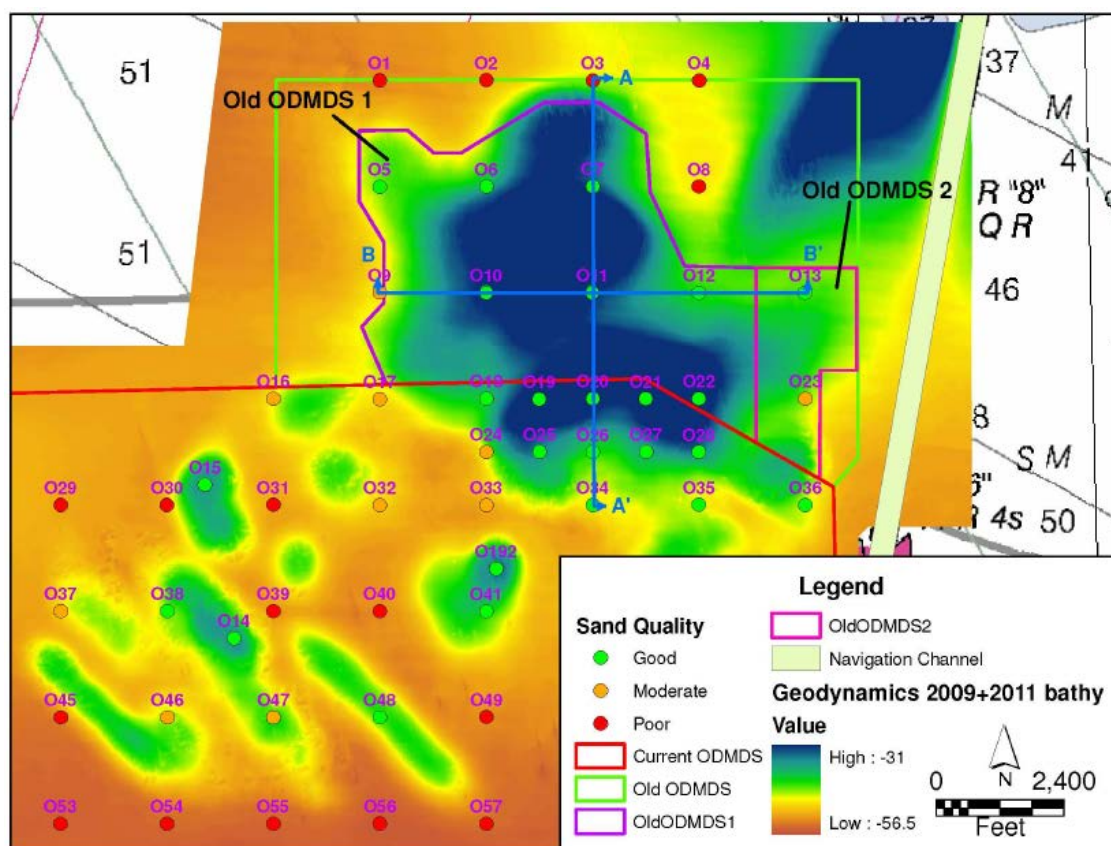
Figure 3-5: Old ODMDS Site and Vibracore Locations (Coastal Tech, 2013)

This site is located directly north of the Current ODMDS in State waters. The Old ODMDS was split into two sections; designated Old ODMDS 1 and Old ODMDS 2, to maximize the potential borrow area volume as shown in Figure 3-5.

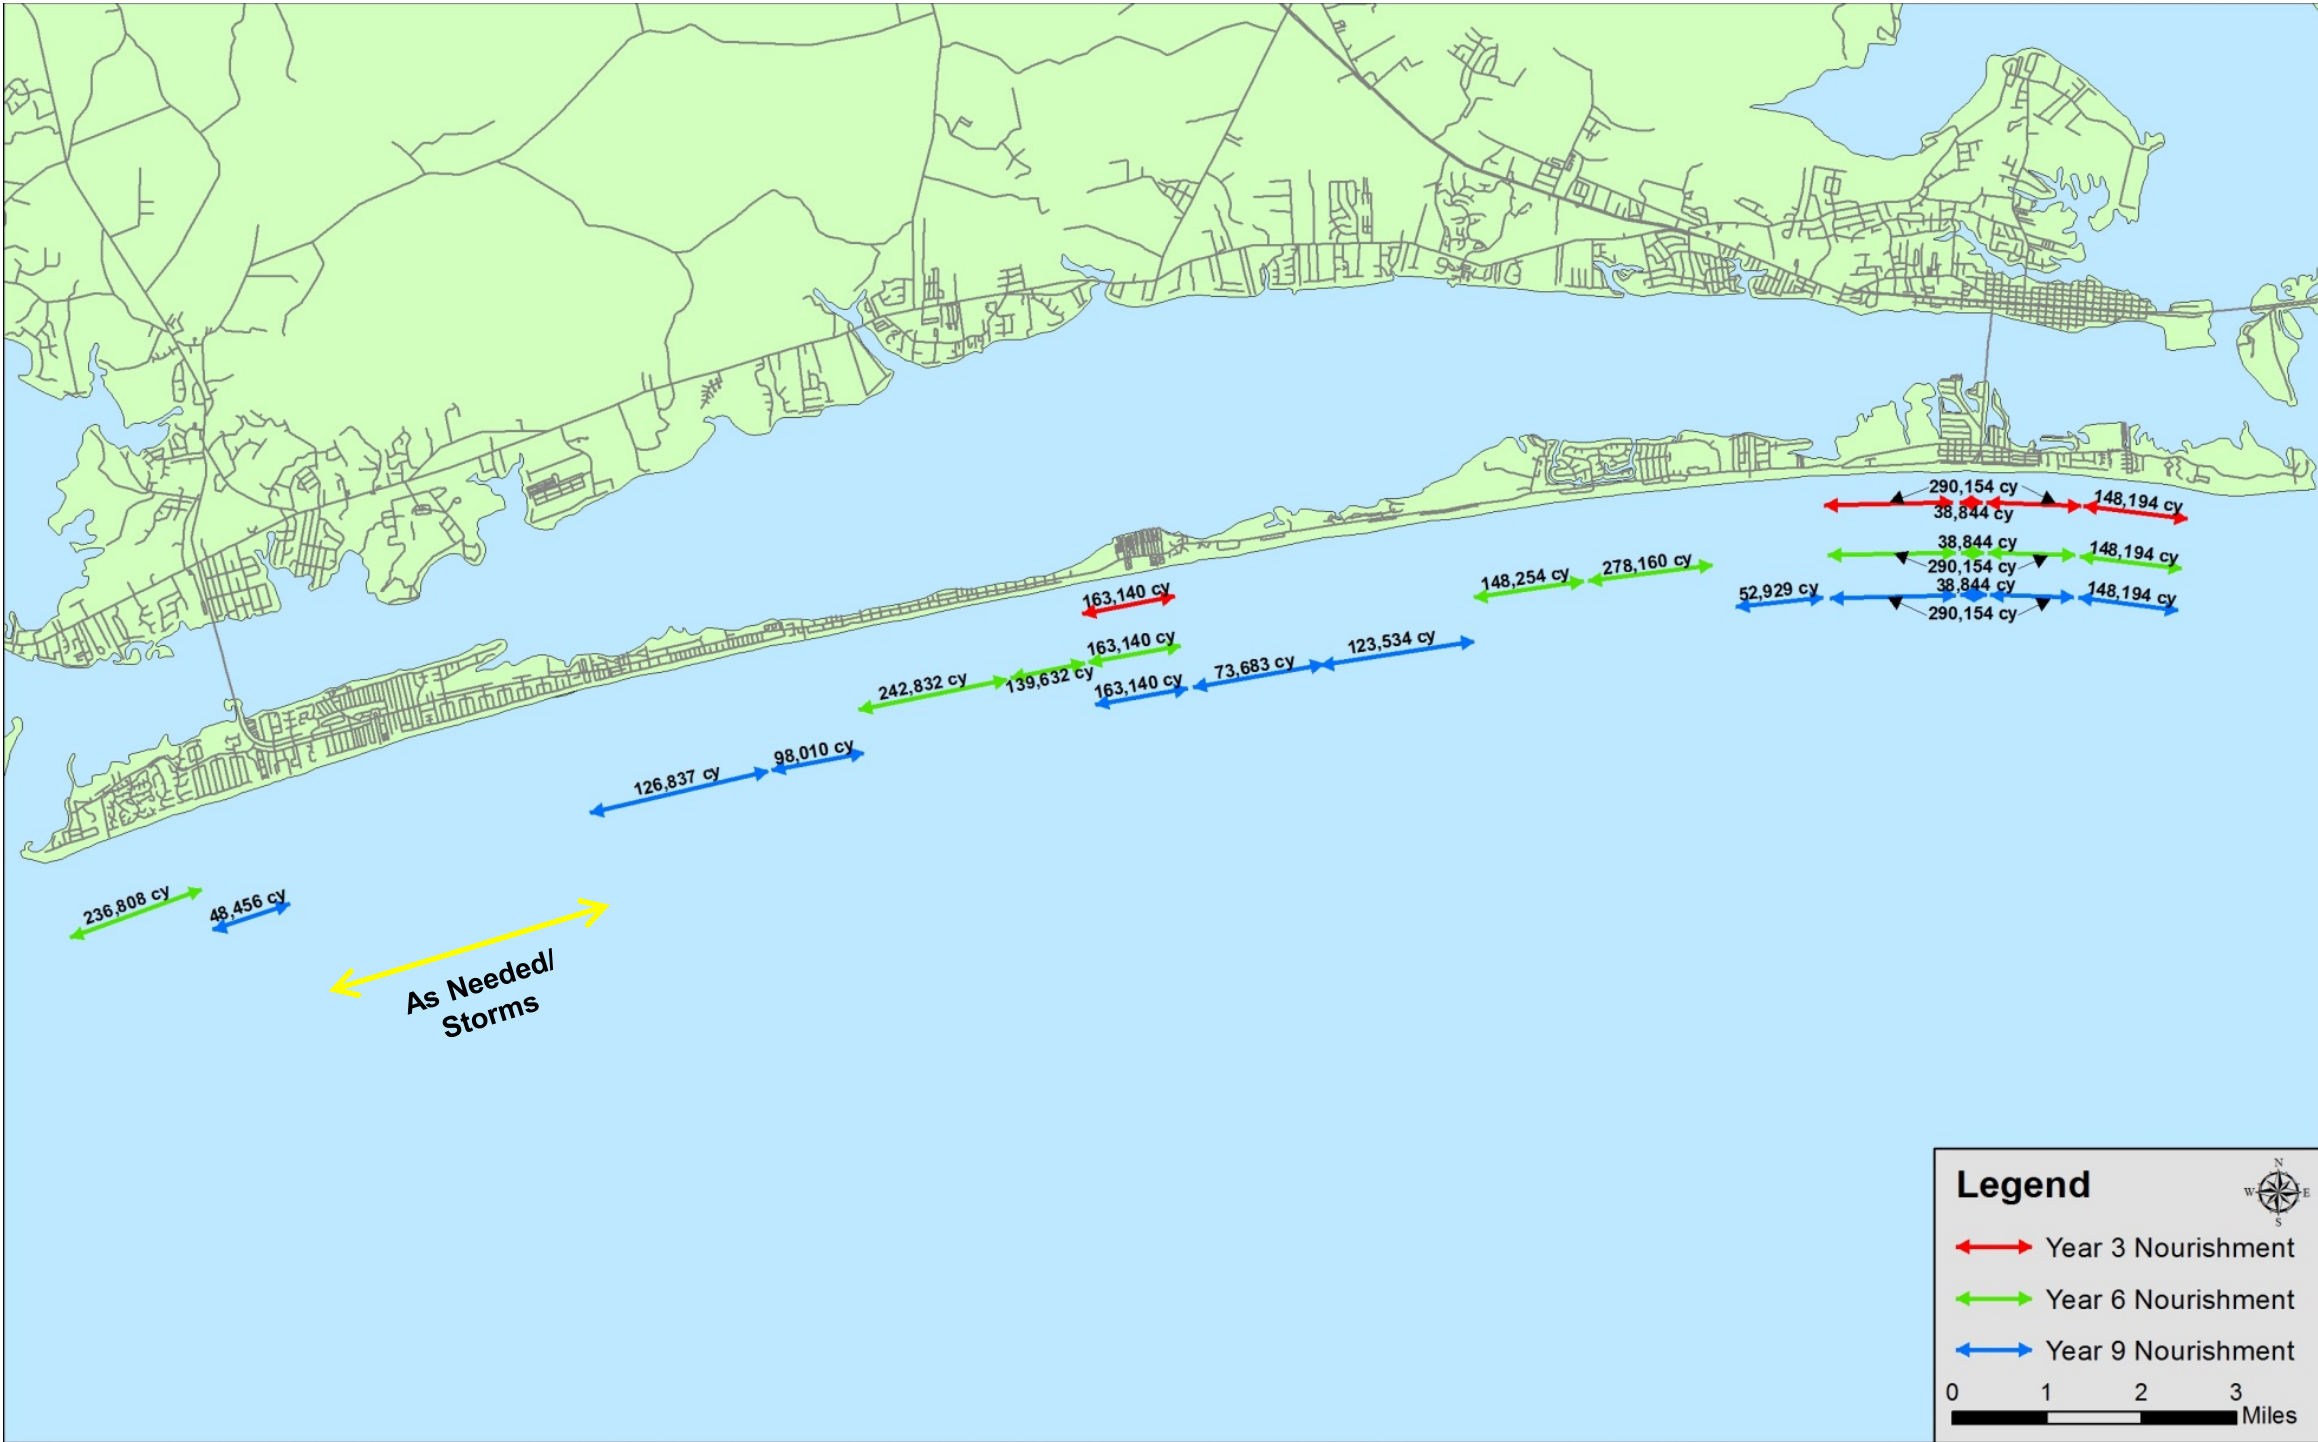
Figure 3-14: Detailed Subreach Nourishment Plan

Once the years for the average 25 cy/ft placement rate to erode away were calculated for each reach, it was found that most of the results for the reaches were close to multiples of 3 years (i.e., 3, 6, 9, etc. years). The results were then tabulated and classified into the various 3, 6, and 9 year renourishment cycles and the required volumes calculated. Table 3-30, Figure 3-14, and Figure 3-15 show the results as well as the preliminary proposed projects over the next 50 years. Please note that the nourishment volume approximates the need for background erosion only. It is expected that named storm losses will be handled separately through FEMA reimbursement projects.

Based on the results above, one can see that some reaches will require more sand than others based on localized and regional erosion patterns. The inlet/dredging effects at Atlantic Beach and Bogue Inlet as well as the hotspots at Pine Knoll Shores-East and Emerald Isle-East are apparent and reflect the greater need for future nourishment, while historically sand receiving areas at Emerald Isle-Central and West will require less sand comparatively. The Management Reach nourishment plan will likely be the one most closely followed in the future, but again, storms and other factors will likely override the above approach in reality. It should also be noted that the results above do not include the storm need volume. It is assumed that these projects will be funded by FEMA once the new nourishment triggers and engineered beach with the 25-year return period event LoP have been accepted by FEMA.
